Retrofitting Residential HVAC Systems

In this case study, we show how DOE's Best Practices Guide For Residential HVAC Retrofits works—as well as some of the installation practice and building code official problems that can arise.

by Jennifer A. McWilliams
and Iain S. Walker

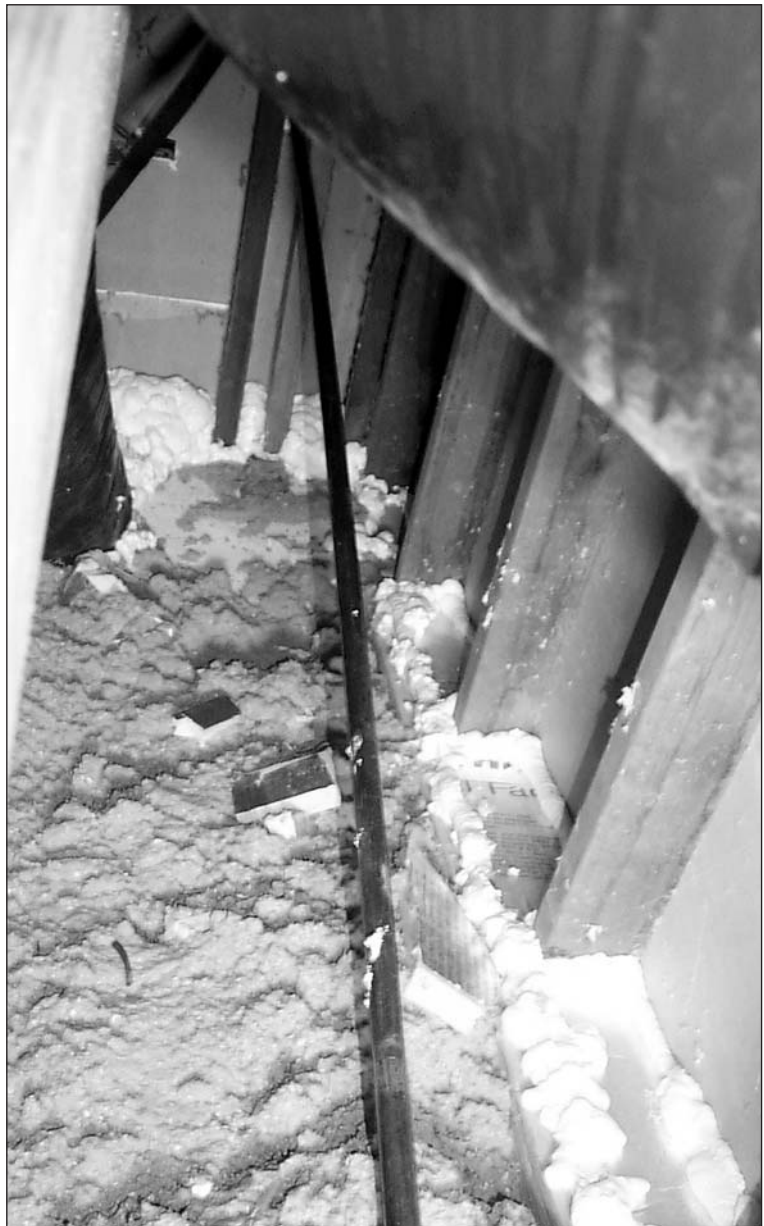
It's important to seal cavities connecting the house to the attic. Foam was used for sealing small holes and cracks at building component intersections.

The ducts were sealed using mastic and internal aerosol sealing. The supply ducts were sealed to 4% of air handler flow, but the return leakage was higher than we would like at 9% of air handler flow. The remaining return leakage was mostly at the economizer damper seal because the sheet metal box containing the economizer damper was not installed squarely. The sealing of the envelope was very successful—mostly because this particular house had significant large leaks that we were able to access. We sealed over 1,200 CFM of leakage at 50 Pa—about one-quarter of the total leakage. This included air sealing the attic floor plane (see photo on p. 28), the old cavity return (shown in photo, above), and plumbing penetrations.

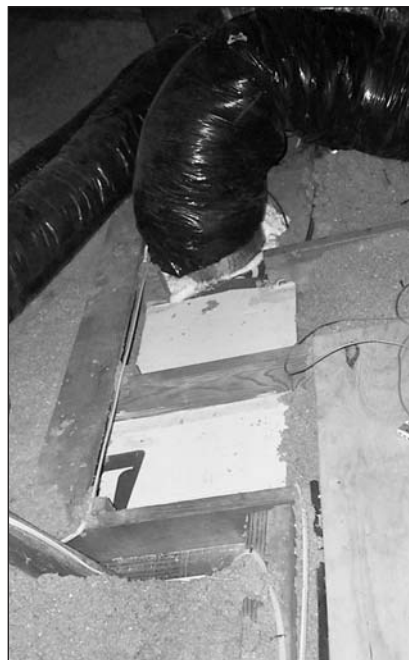
Duct board insulation was used to block off large open areas.

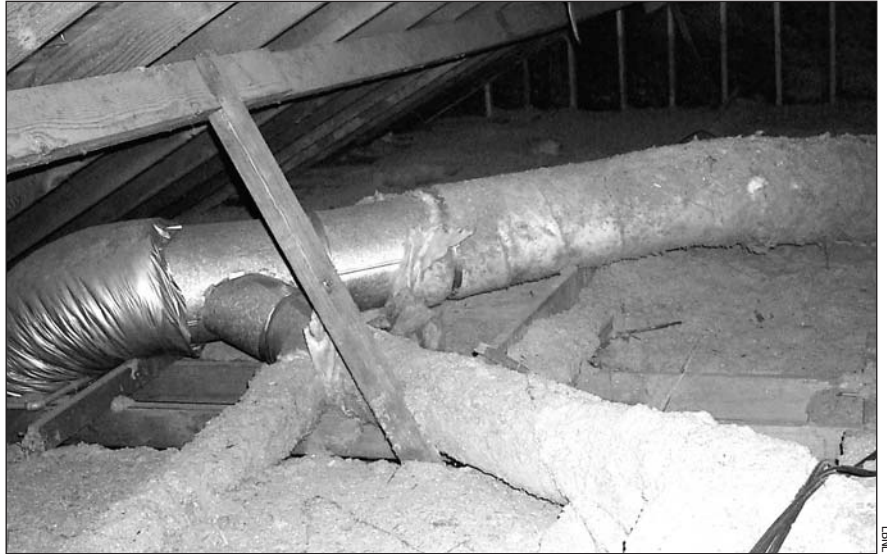
Here we see the poorly insulated sheet metal ducts and blown-in insulation in the attic before the retrofit.

- The metal ducts in the attic were replaced with new R-4 flexible ducts (despite clear and repeated instruction to retain the original ducts) because the contractor thought the original ducts were undersized. Initially the contractor hung the flex-ducts from the attic ceiling with smooth bends. However, since the ducts would be covered with insulation, the contractor placed the new ducts on the floor, but

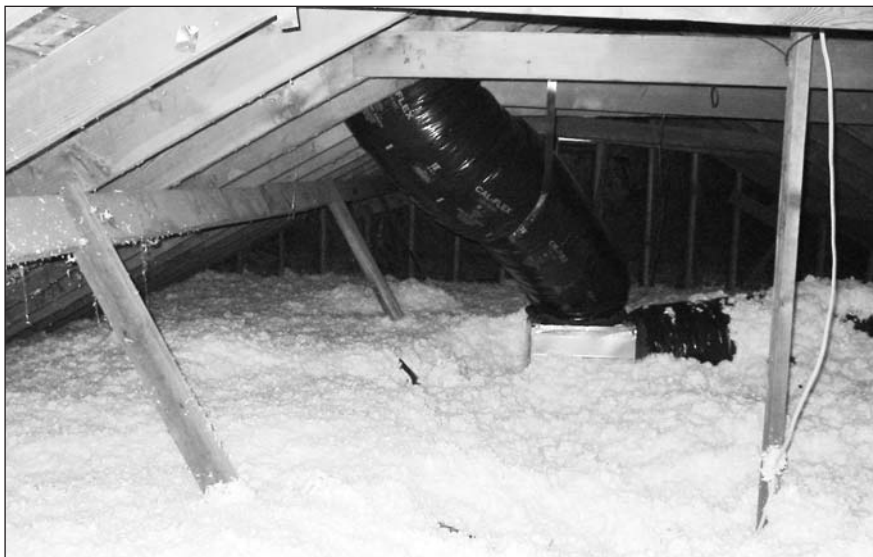
The new flex ducts in the attic are covered by additional blown-in insulation after the retrofit.

unfortunately did not take the time to lay the ducts with smooth bends. The use of flex duct increased the system air flow resistance (that contributes to noise, extra air handler power

consumption, and possibly too low a flow through the furnace and air conditioner). This problem was made worse by the many extra bends in the flex duct due to poor layout.
